Lake Okeechobee: Floating Plant Management

The photos and maps below illustrate the location of Water Hyacinth and Water Lettuce Lake Okeechobee. Google Earth imagery is used solely to show the GPS location of where photos were taken on the lake, the imagery is not used for plant management decisions. Floating plant acreage is estimated to be around 665 acres as of the June interagency flight. Lake Okeechobee being in maintenance control for floating plants will greatly diminish the volume of plants being treated and the amount of herbicide being used on the lake. Maintenance control will also lower, if not eliminate the occurrence of boat ramp, boat locks and canal navigational closures due to floating plant blockages.

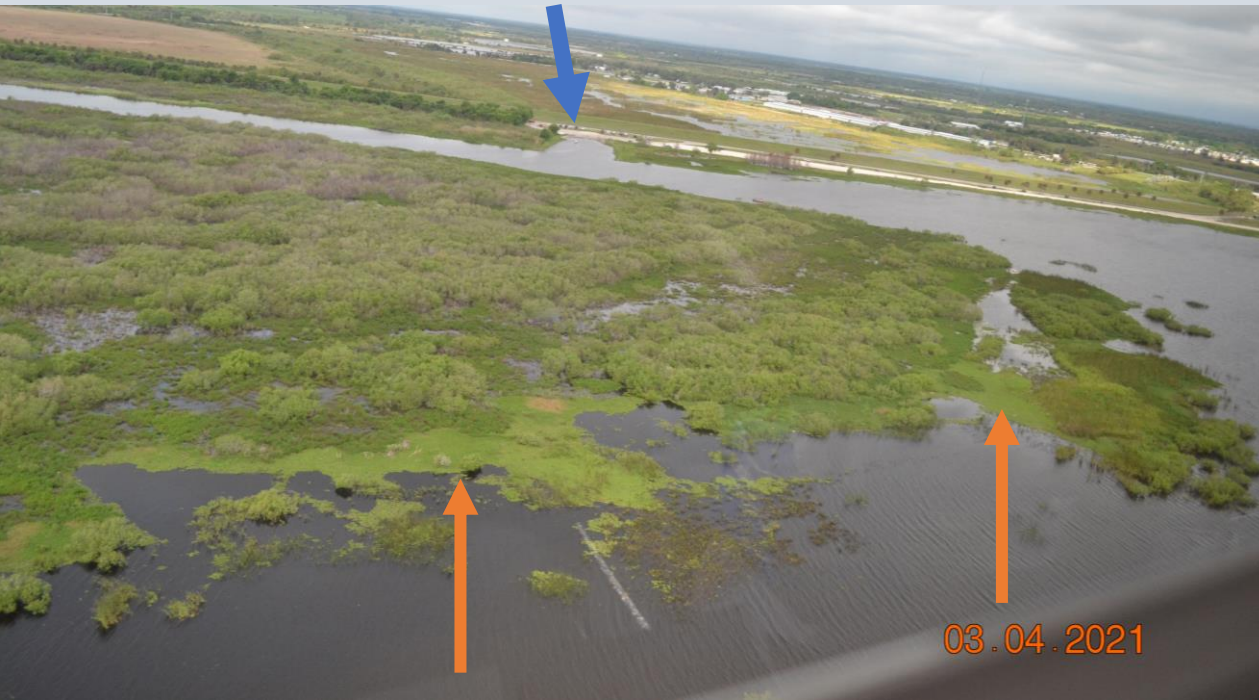
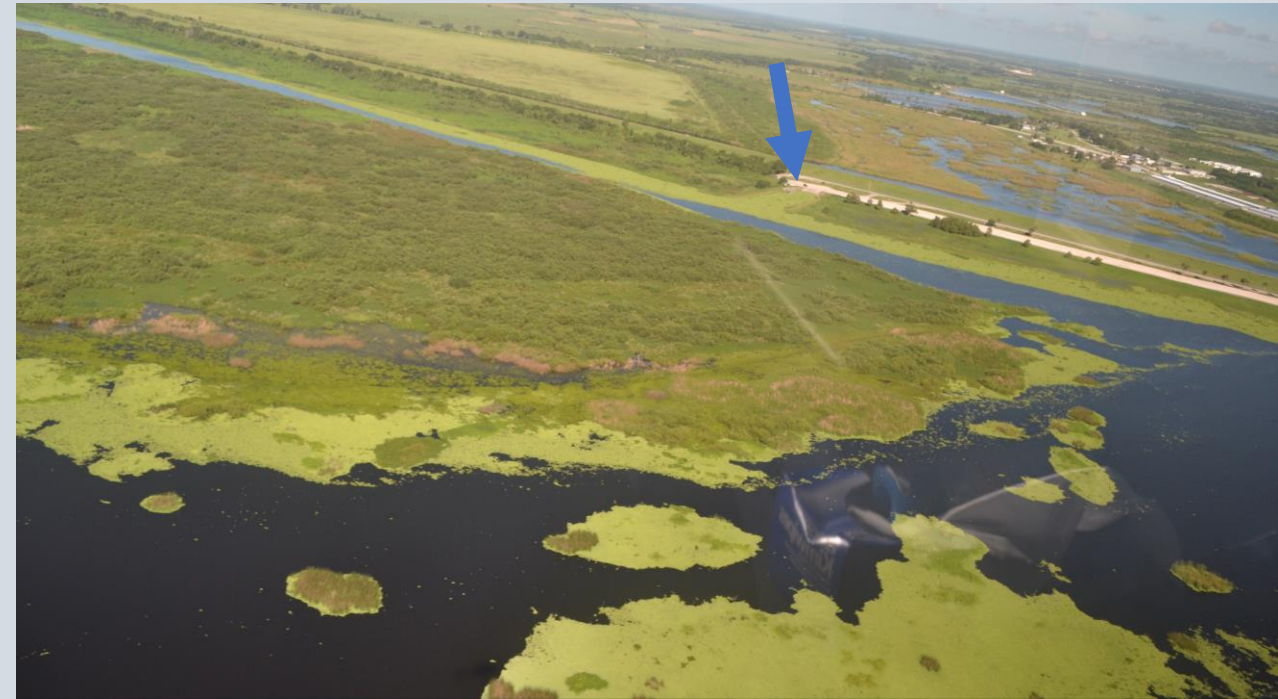
Maintenance control is a management philosophy of managing invasive plants at the lowest feasible levels. The maintenance control goal for Lake Okeechobee has traditionally been 500 acres. Managing floating plants at these levels reduces the volume of plants being managed as well as the amount of herbicide being used. Floating plants can double in size every 7-14 days with close to exponential growth potential. When floating plants are out of maintenance control on the lake large volumes of plants can be pushed by wind to block navigational channels, boat ramps/locks and water control structures. These blockages can take weeks and even months at time to clear. The photo on the left shows floating plants beginning to expand in Eagle Bay at a level warranting management as to prevent the potential of the plants expanding to levels shown in the photo on the right from August 2020 interagency flight.

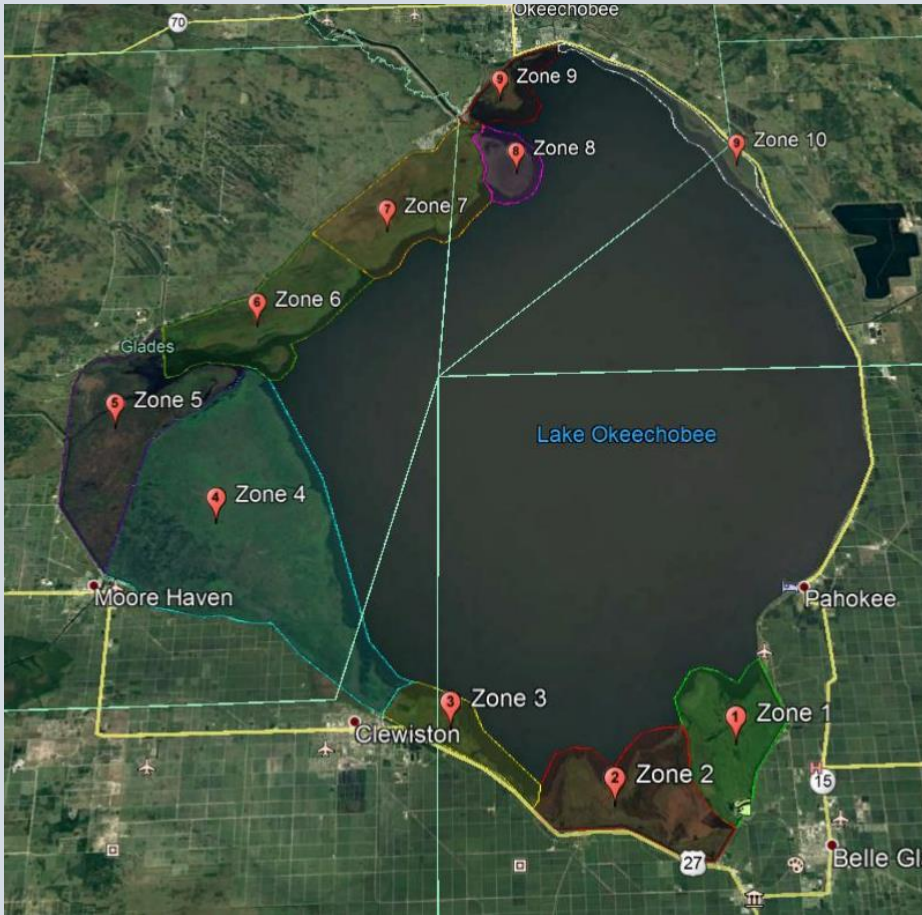
Interagency flight May

Zone 4 has by far the highest accumulation of floating plants. The nutrient reduction project area near Indian Prairie is the primary influencing factor for the high floating plant acreage in zones 6&7.

Lake Zones	Average
1. Torrey & Kreamer	10.75
2. Ritta	35.5
3. East Wall- Coot Bay	17
4. West Wall – Whidden	291.5
5. Fisheating Bay	28.5
6. Harney – Indian Prairie	134.75
7. Indian P.- Kissimmee	99.25
8. King's Bar	12.625
9. Kissimmee- Taylor Cr.	24
10. Taylor Cr.- Chancey	11.25
TOTALS	665.12

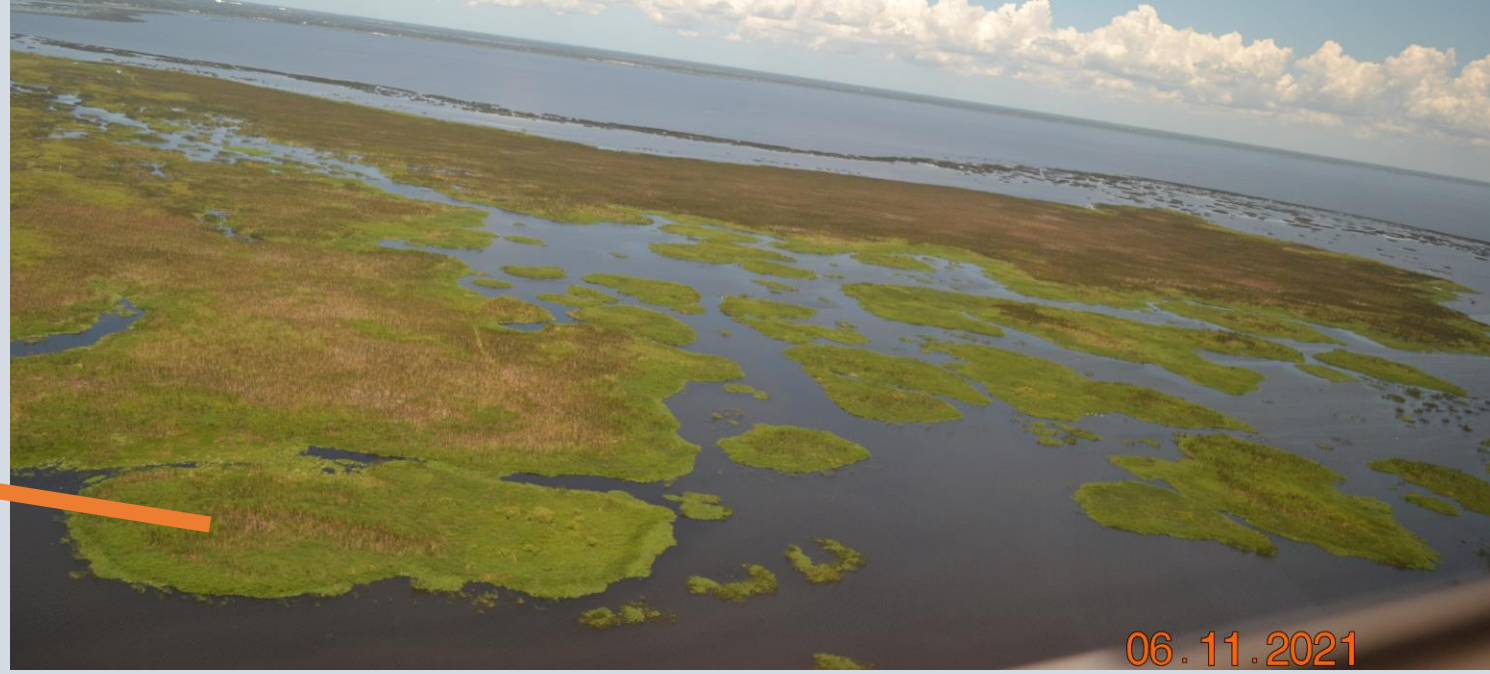
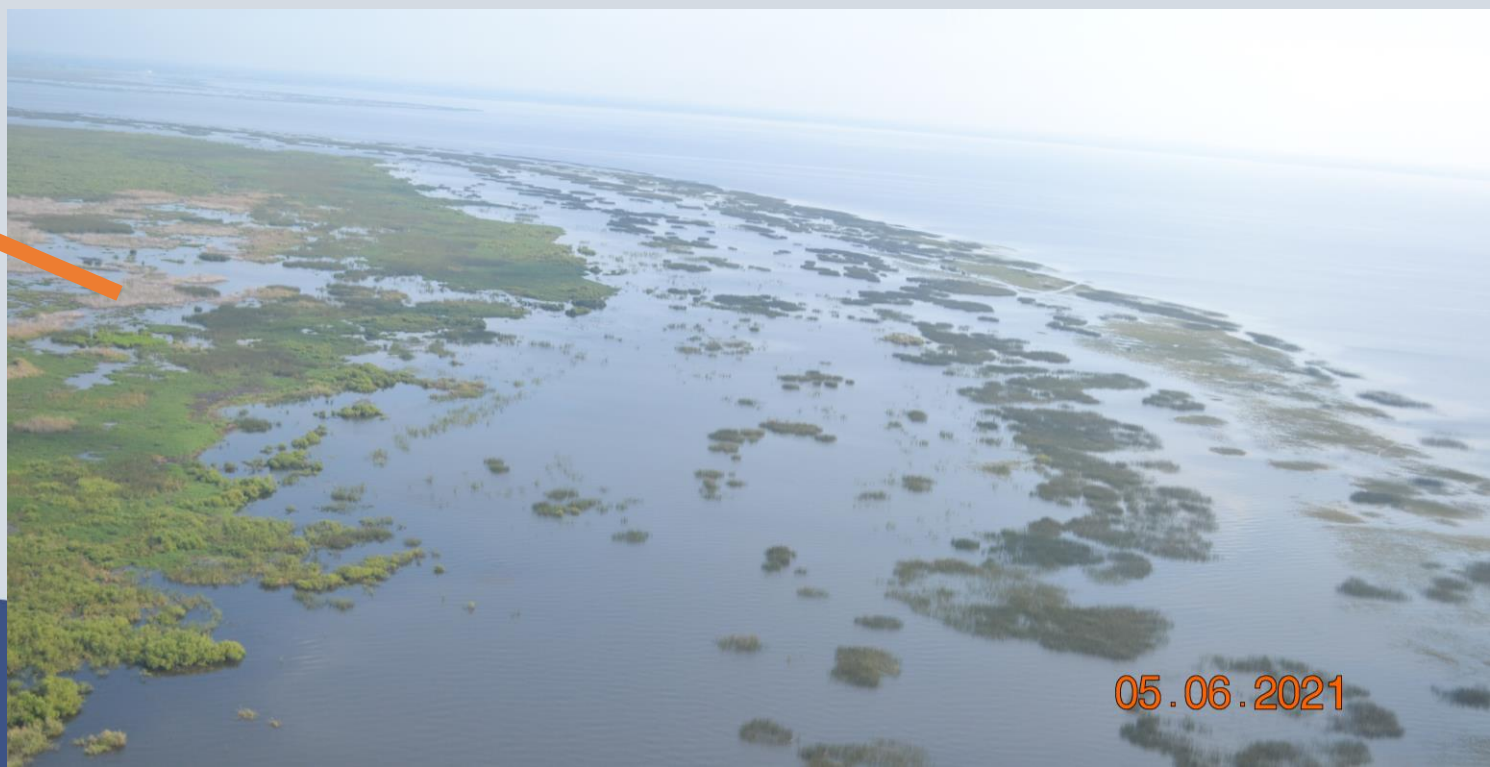
The top photo shows floating plants beginning to expand within Eagle Bay Island in zone 9. The bottom photo shows the northeastern tip of King's Bar in Zone 8 where both Water Lettuce and Hyacinth build up.

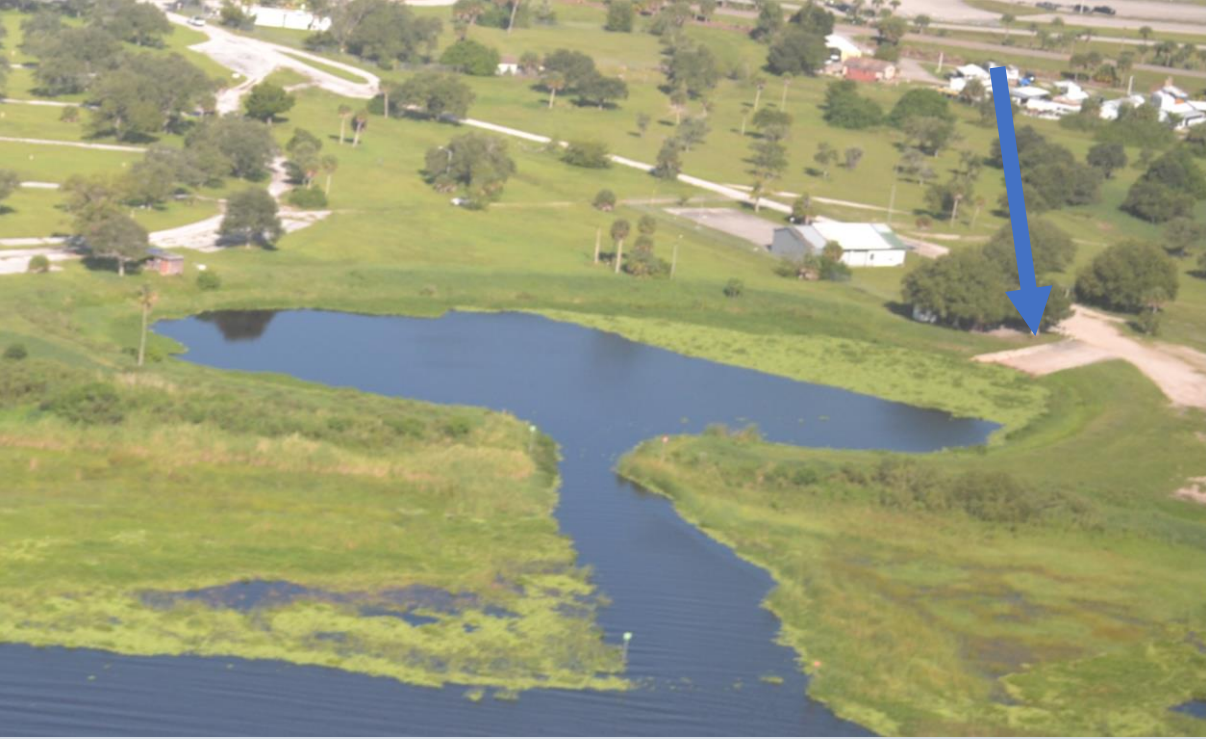
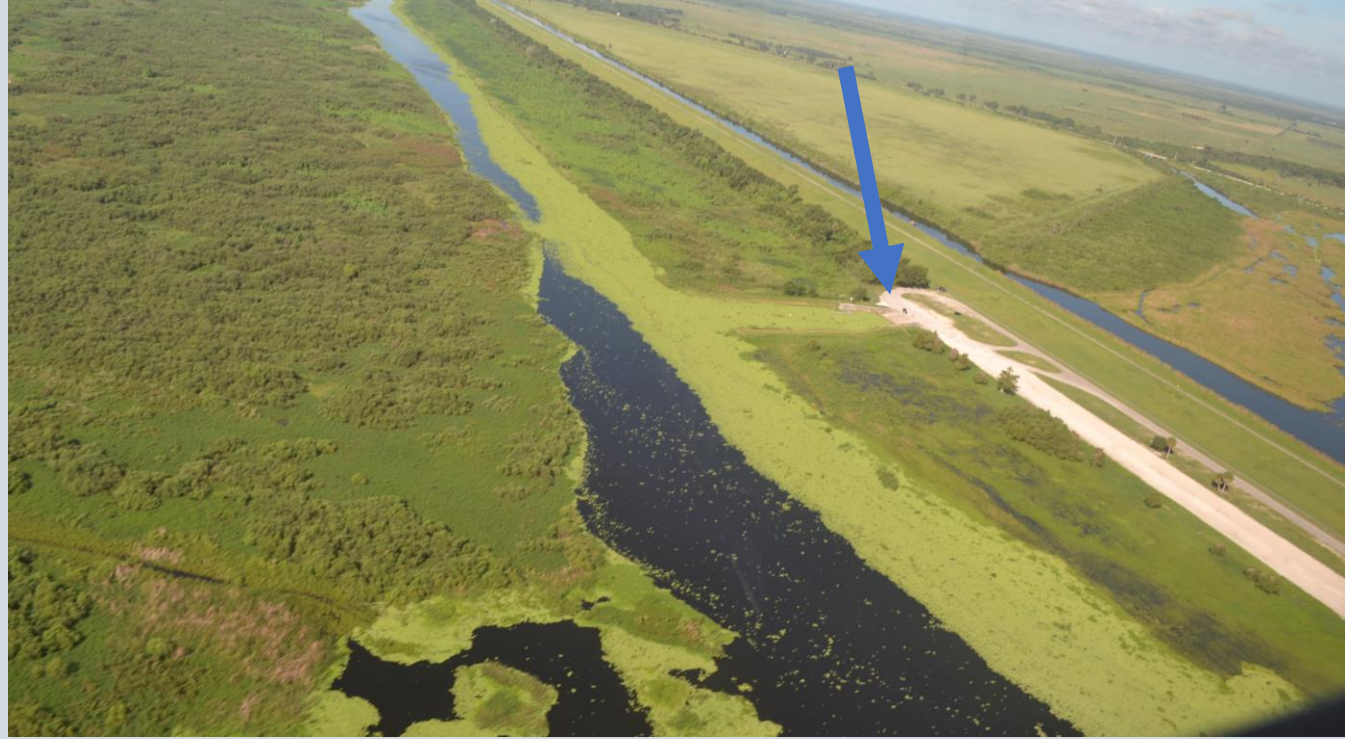
Proactively managing floating plants can prevent incidences like ones shown in the above photos. The photo on the left shows the Okie-Tantie Airboat ramp (blue arrow) blocked with floating vegetation taken on the August 6th, 2020 interagency flight. The photo on the right was taken on the same interagency flight and shows the Lock-7 boat ramp (blue arrow) in Eagle Bay completely blocked by floating plants. This was the result of the lake being out of maintenance control. The Okie-Tantie boat ramp blockage was cleared relatively quickly but the Lock-7 ramp blockage took 2-3 months to completely manage and restore public use. Treating floating plants before they become an issue like the ones pictured above not only reduces the number and frequency of boat ramps, boat locks and navigational blockages but also drastically reduces the amount of herbicide used on the lake to manage floating plants.

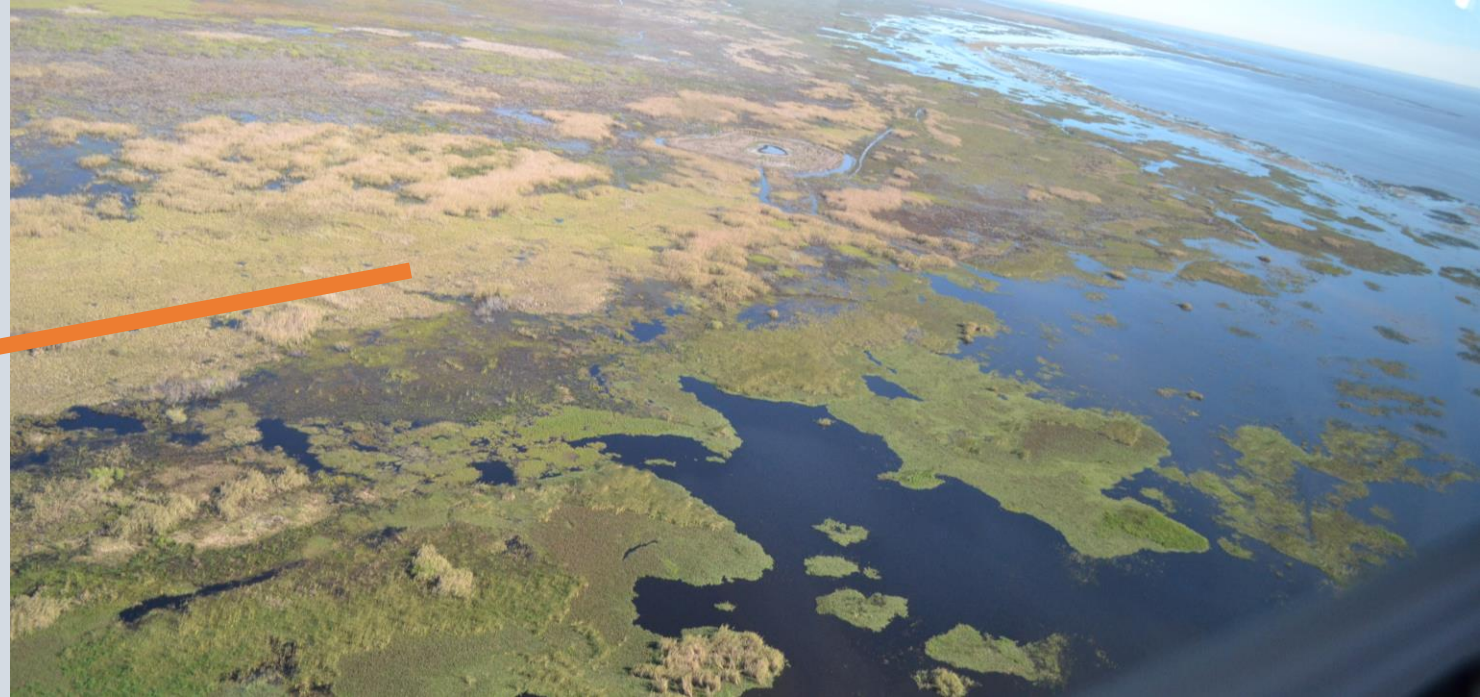
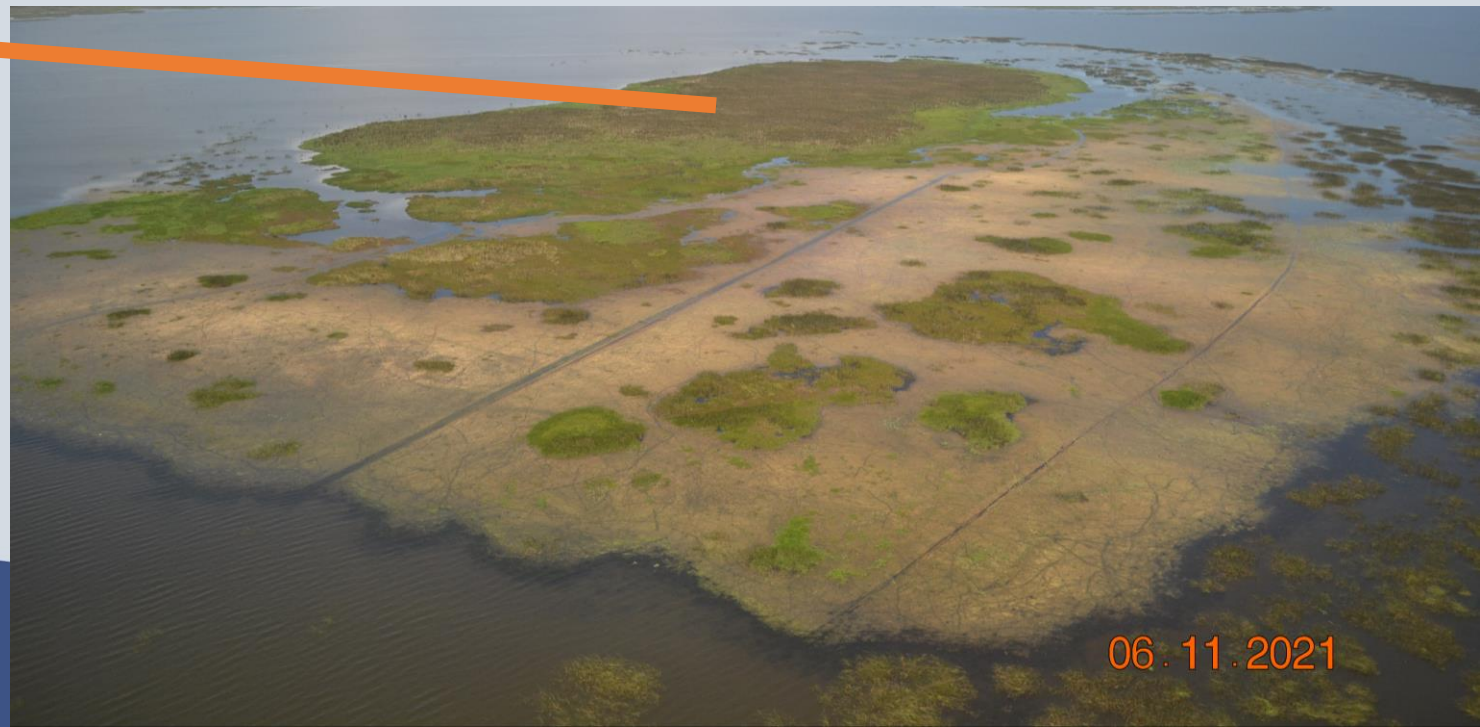
Top right photo shows the southern end of Zone 7 where floating plants have not been managed for over a year. A mechanical project is expected to take place in this location in spring 2021. The bottom photo show Bird Island where an ongoing research moratorium project is ongoing. No floating plant management treatments are to take place while being monitored long term.

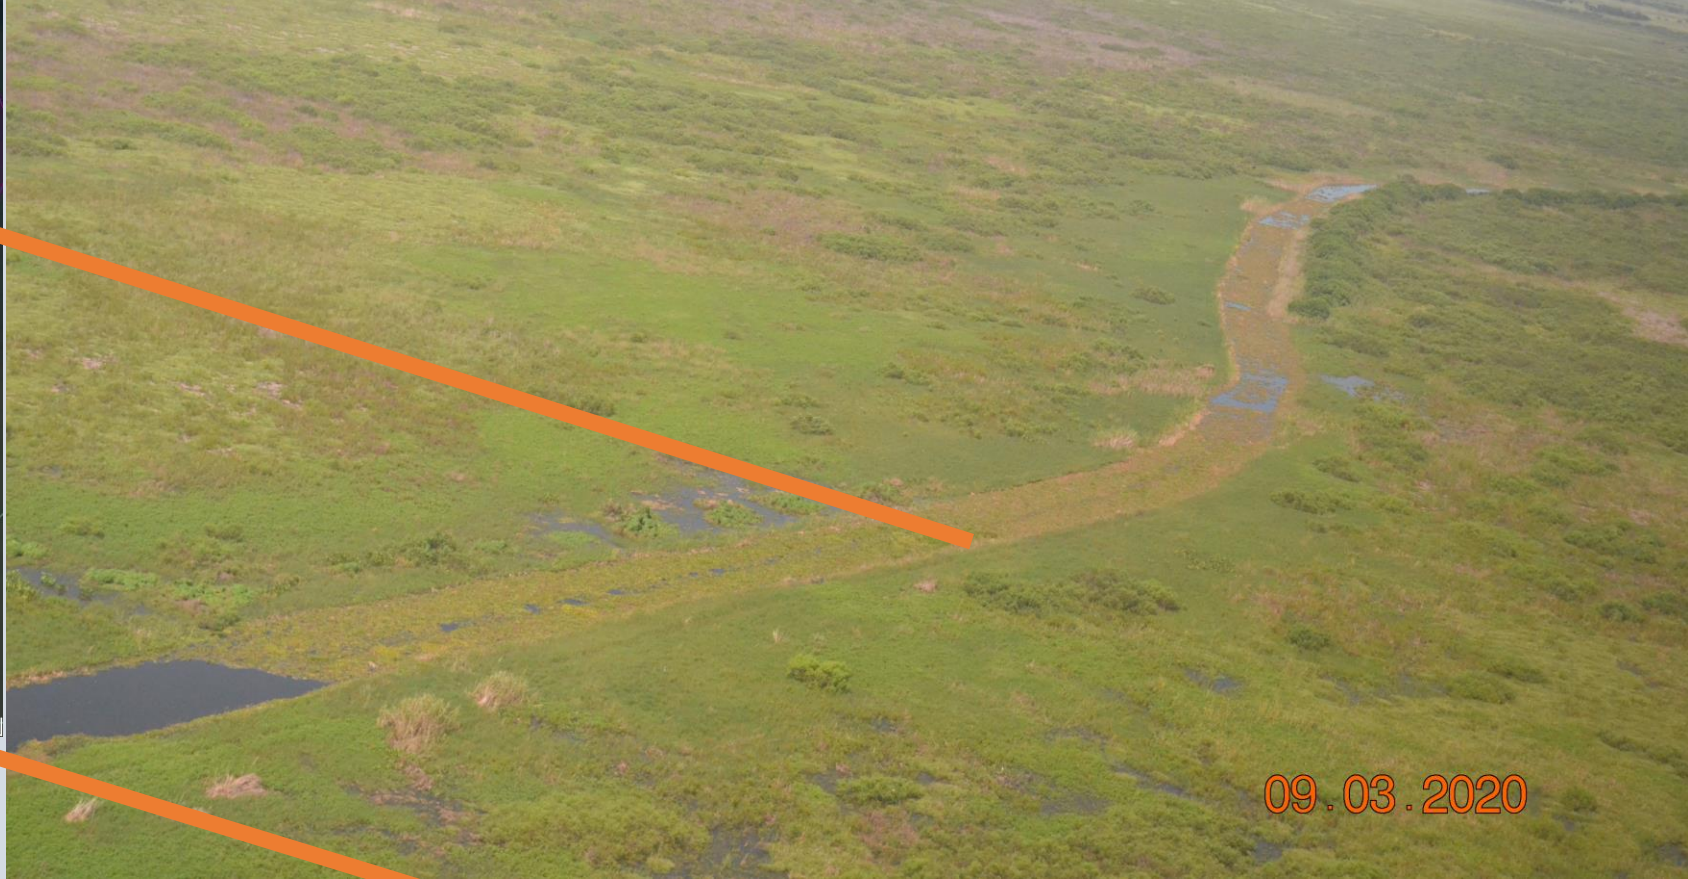
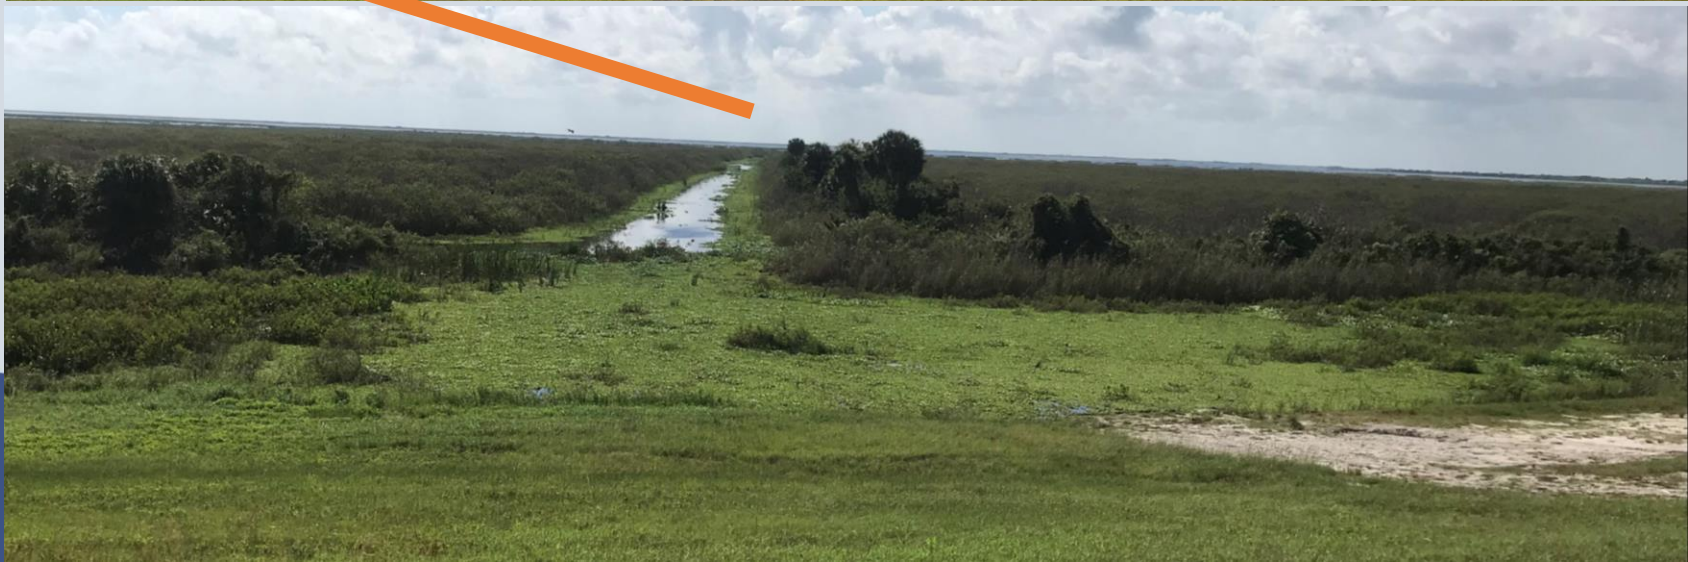
Photo to the right shows Pierce Canal clogged with around 20+ acres of floating plants. Keeping floating plants at maintenance control levels will prevent massive blockages like this one which took over a month to clear. High floating plant levels also resulted in multiple blockages of the Dyess Ditch boat ramp like the one pictured below from October 2019.

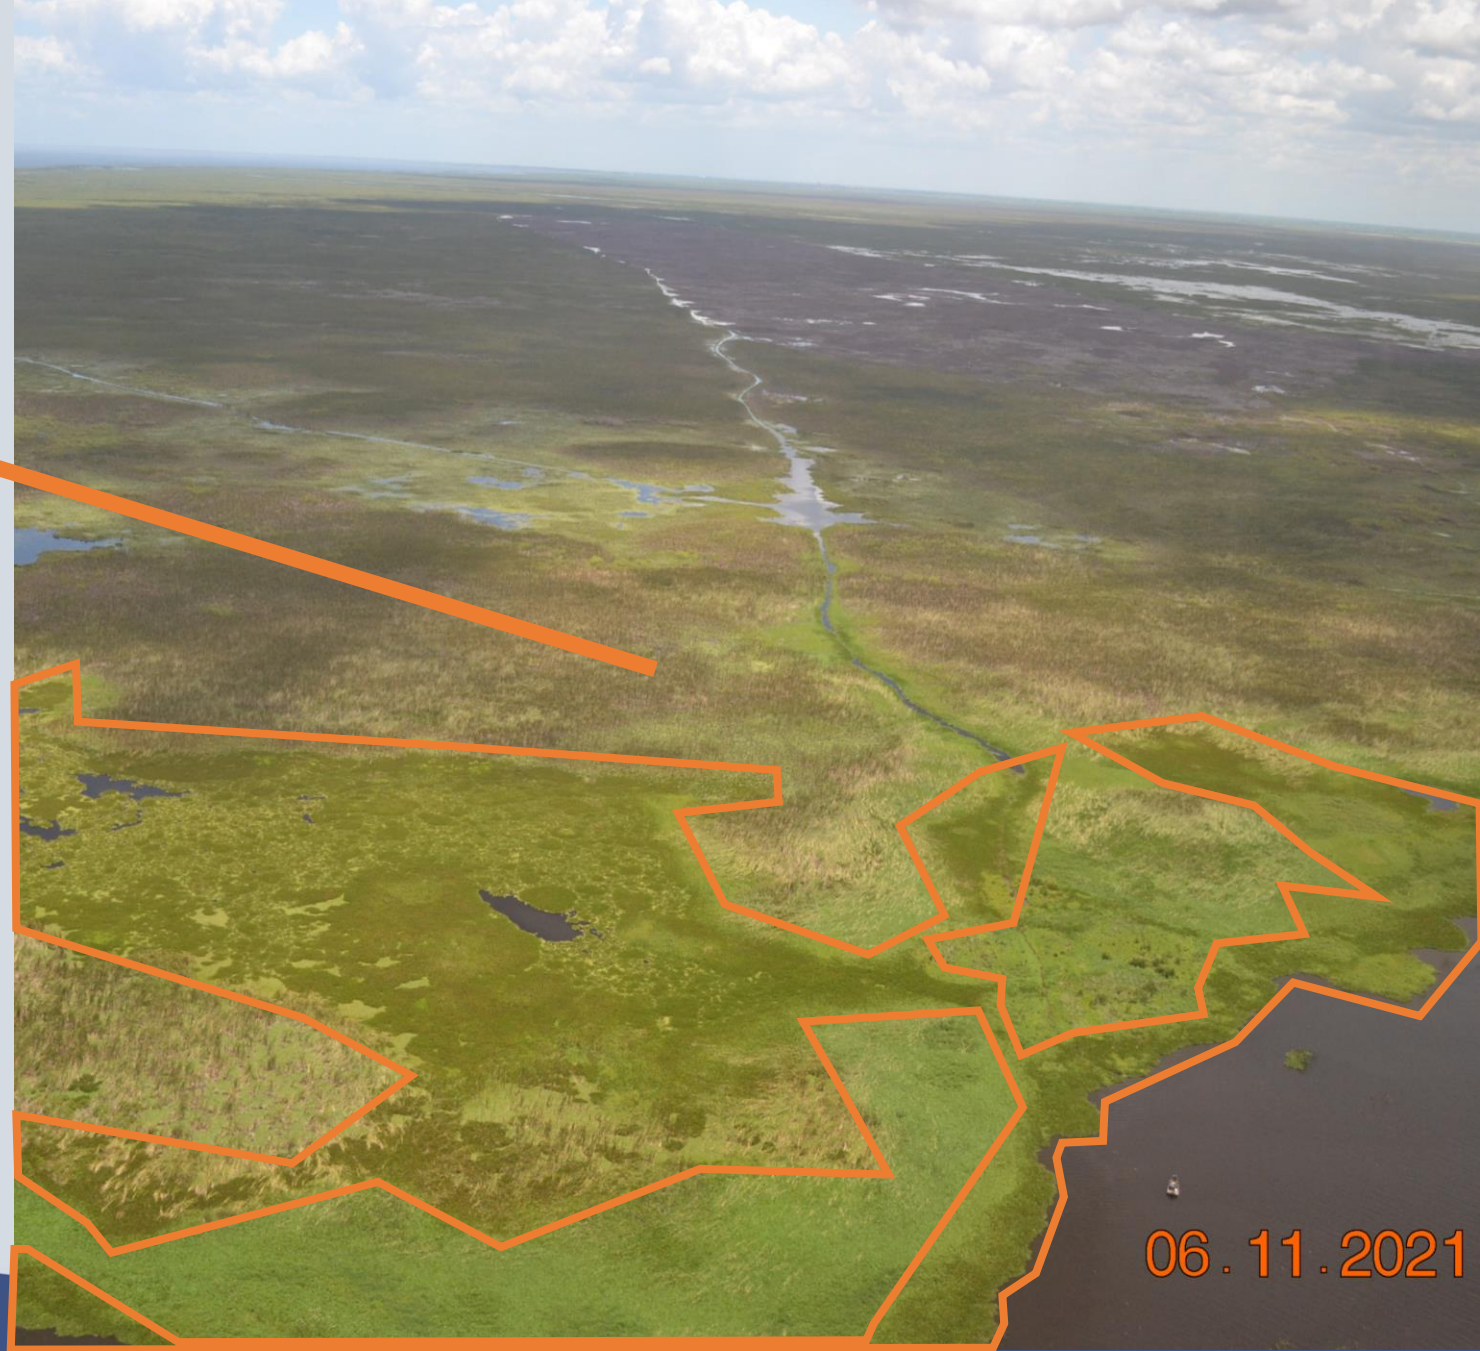
Photo to the right shows part of a large accumulation of floating plants built up along the northern edge of Zone 4.

AAM will move from zone 6 to zone 4. Most of the work in Zone 4 will take place along the marsh edge where large mats of floating plants have accumulated and are expanding over SAV beds. Zone 4 is expected to take 8-10 weeks to fully sweep.

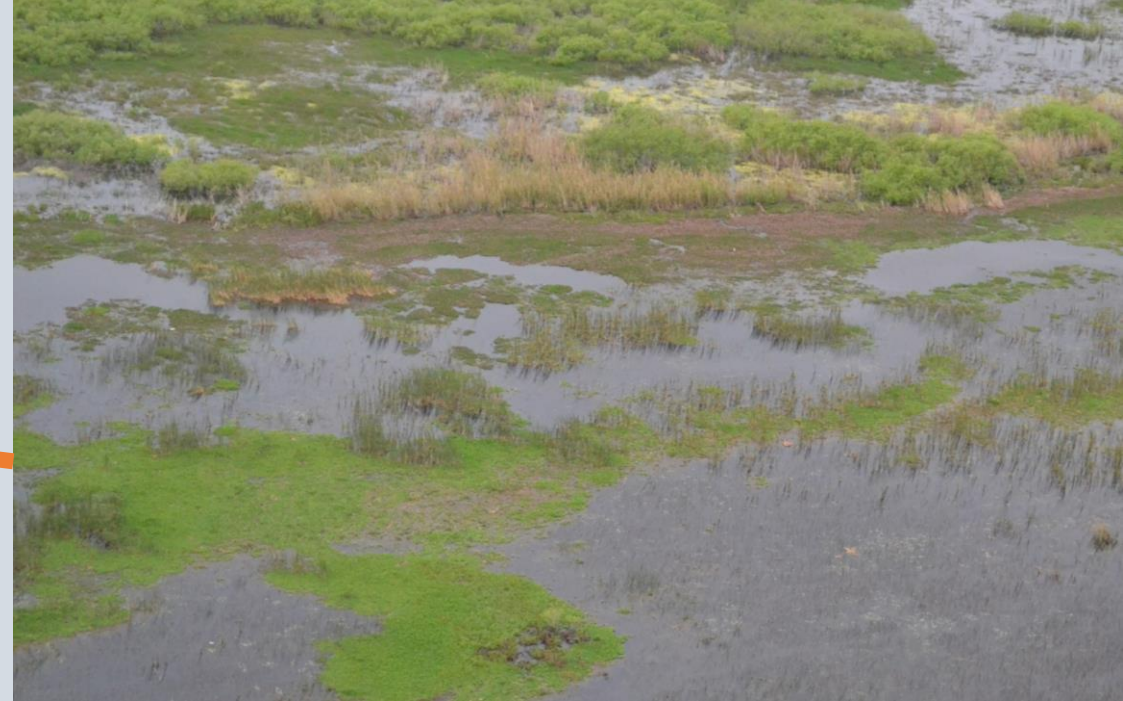
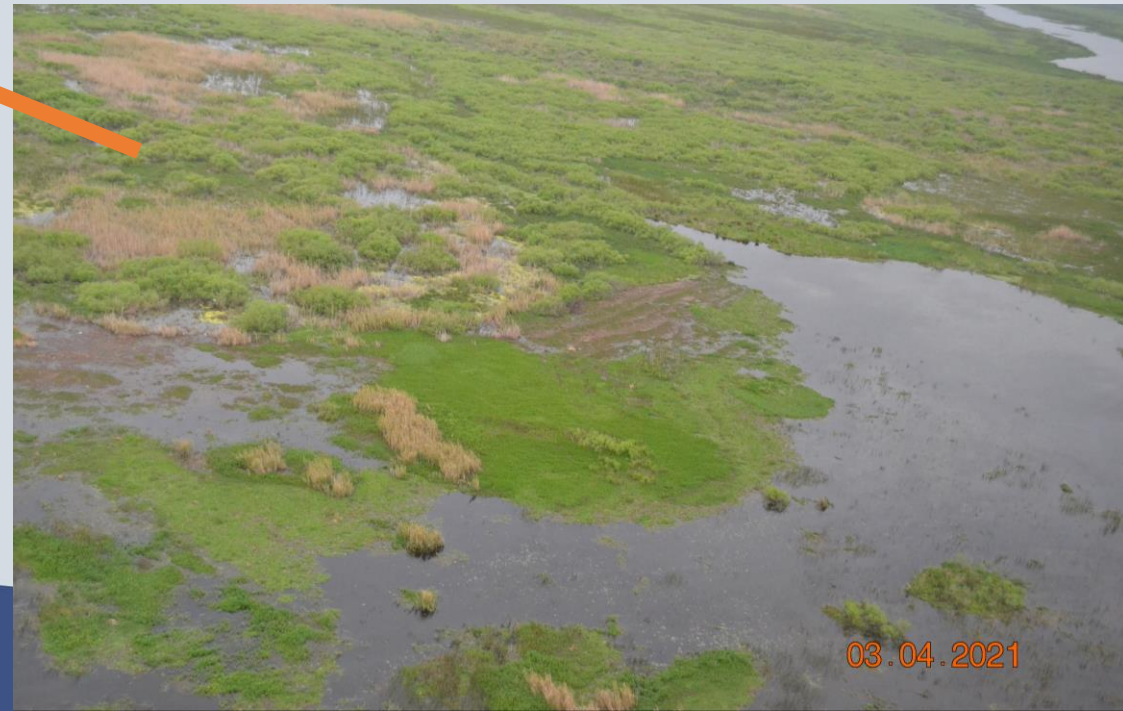
Zone 4

Photo shows one of the areas needing a re-treatment on the marsh edge in the western marsh. This zone contains a majority of the lakes floating plant acreage with 291 acres. Finishing up the treatment here will help native SAV beds expand.

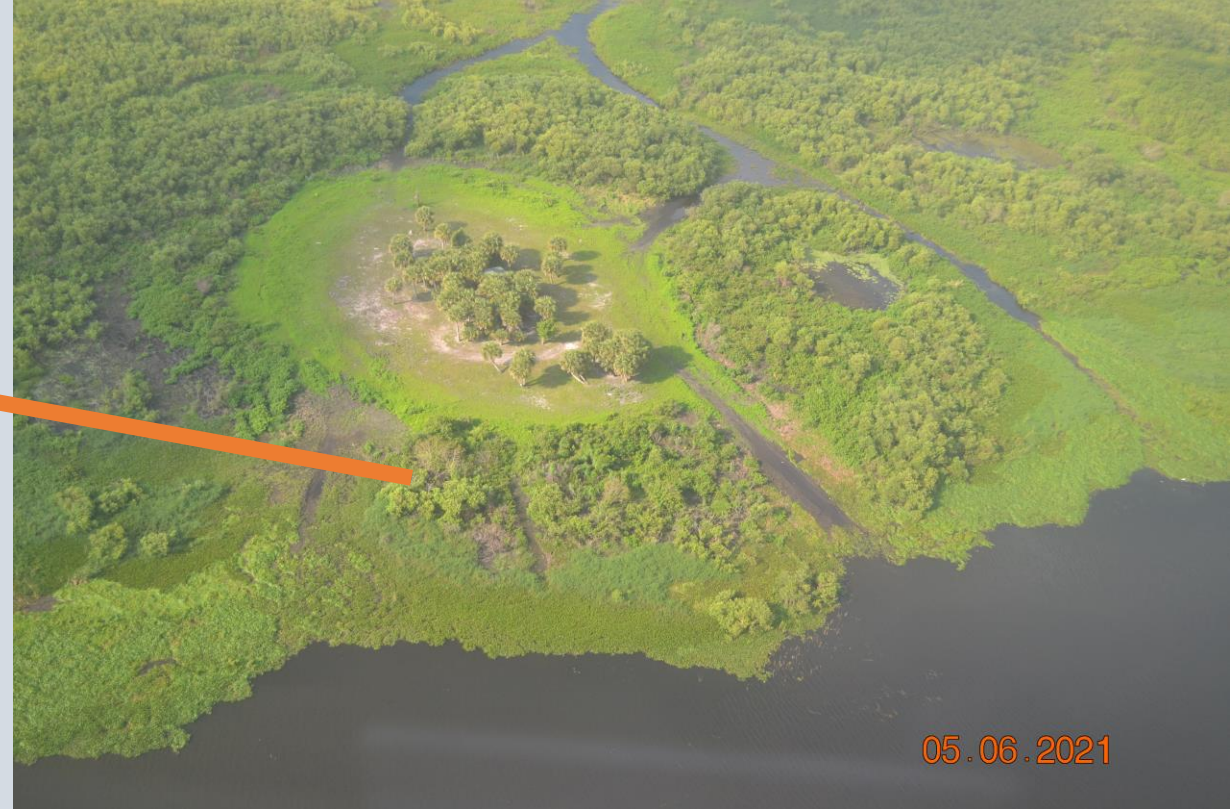
Zone 5

Photo to the right shows thick band of floating plants building along the edges of a spoil island. Floating plants tend to build up in the western side of the lake in the summer. After zone 4 has been completely swept sweeping through zone 5, focusing on the southern end of zone 5 should keep management ahead of this seasonal accumulations of floating plants.

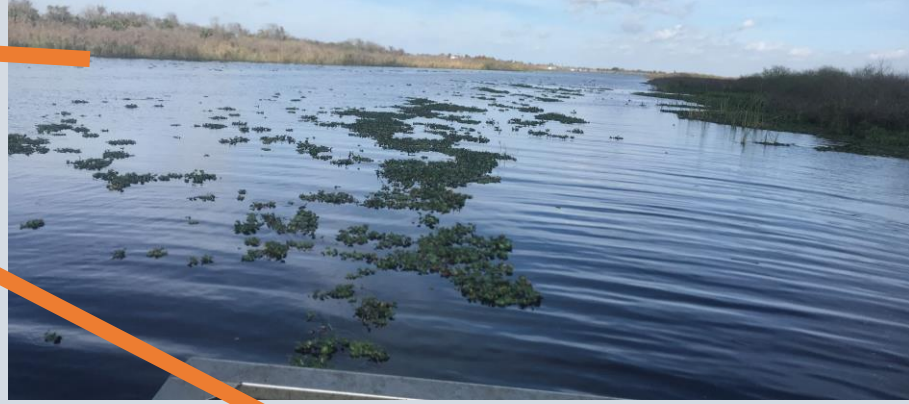
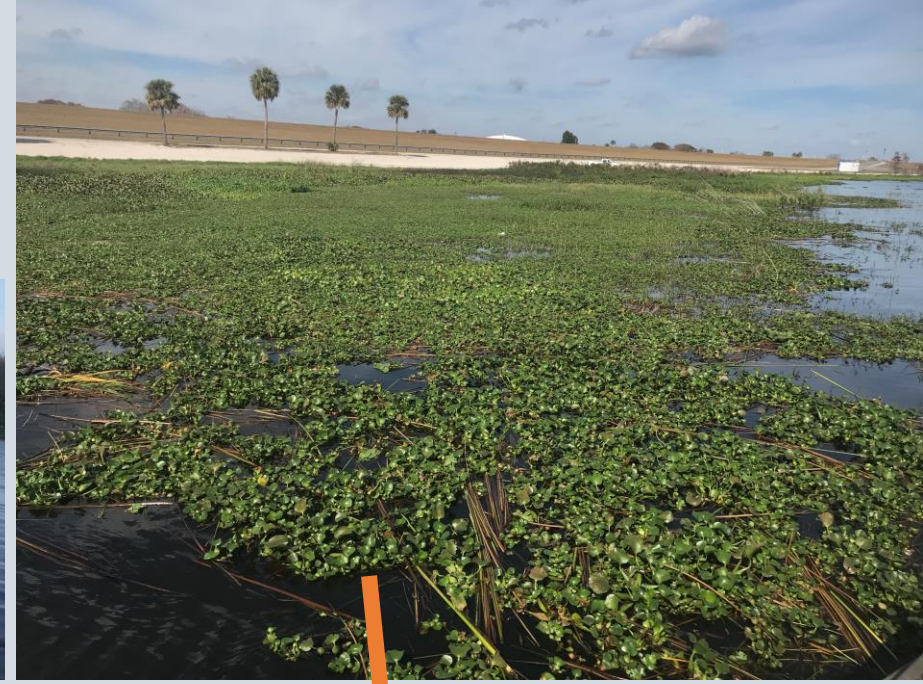
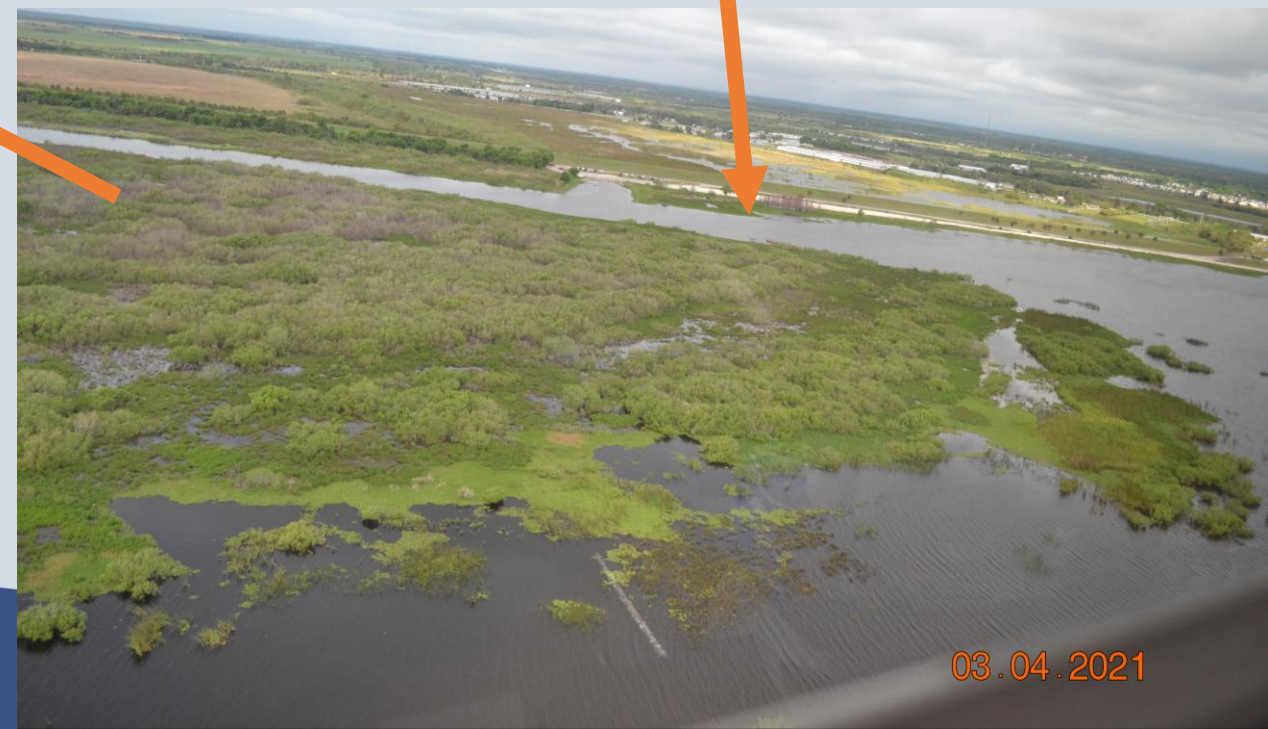
Zone 9

Middle photo shows part of a 25 acre band of floating plants lining government cut which move back and forth with wind. Without management these plants can expand, cut off navigation and block nearby boat ramps. Bottom right photo shows eastern side of Eagle Bay Island where 15 acres of floating plants are located either on edge of the Island or along the shoreline. The shoreline can be seen in the top right photo taken by on airboat survey.

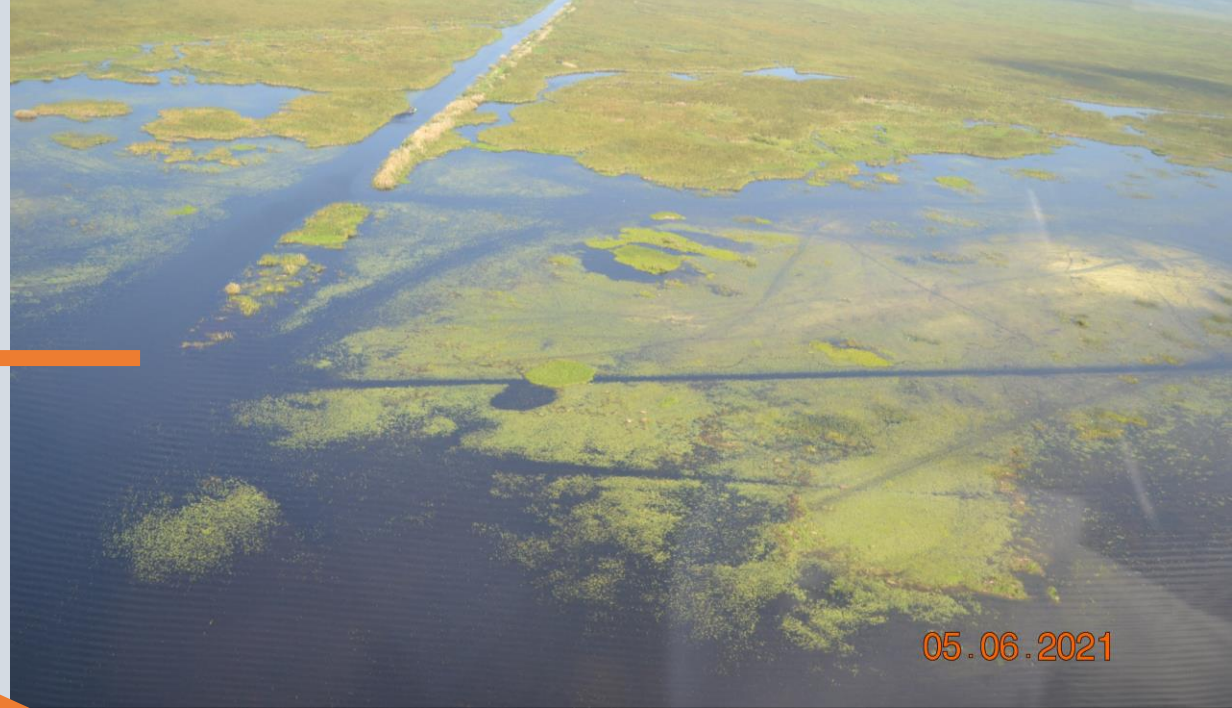
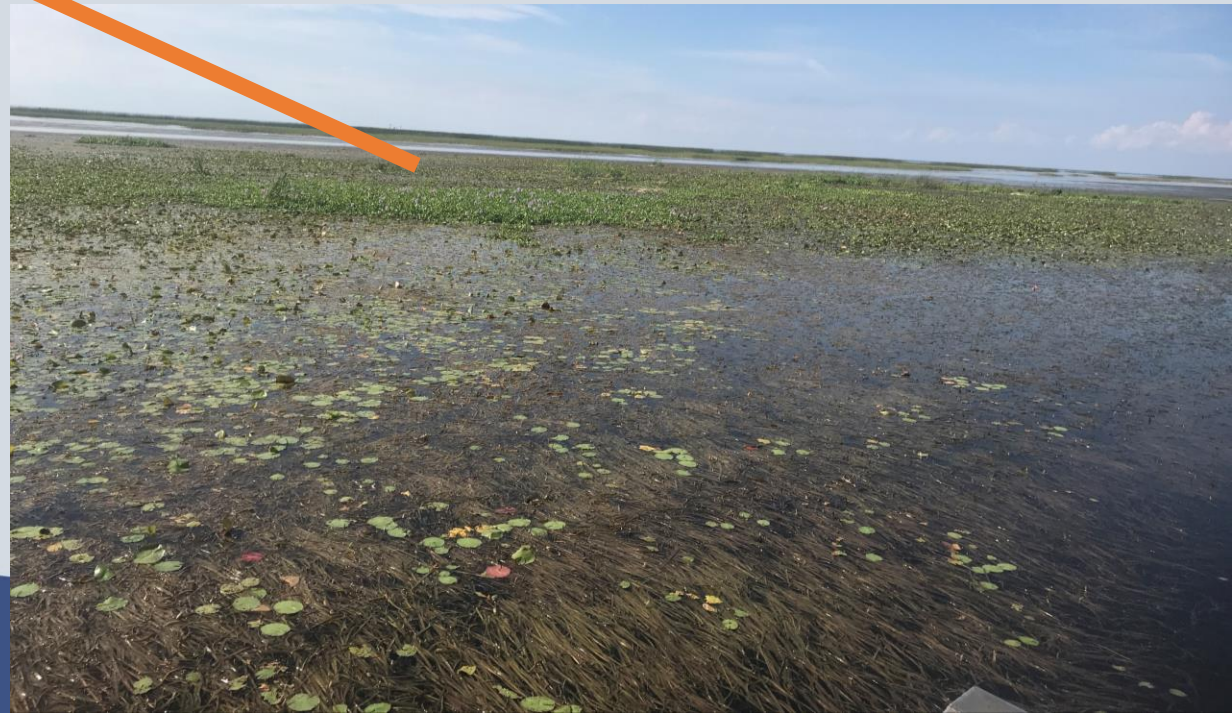
Zone 7

Top right photo shows the end of the Pierce Canal where several mats of floating plants are covering and shading out native SAV. Bottom photo shows some of these same floating plants covering native SAV from airboat survey. Managing these areas will keep the area in maintenance control and will prevent blockages, navigational issues and larger treatments in the future.
